## **INFRASTRUCTURE SUSTAINABILITY: EVALUATING SASKATOON'S 1912 INTERCEPTOR**

**Mark Andrews, P.Eng., AndrewsInfrastructure, Ottawa, ON**  
**Joseph Uglevich, P.E., OCTC Inc, Stow, Mass**  
**Dale Clancy, P.Eng., Infrastructure Services Dept, Saskatoon, SK**

### **ABSTRACT**

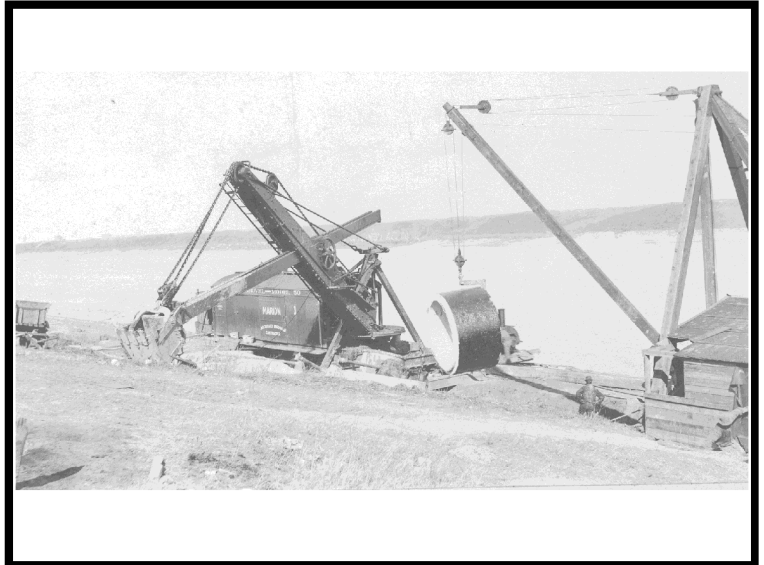
**Photograph 1-1**

Lowering 1800 mm (72") pipe into trench,  
bituminous coating clearly visible

The Interceptor comprises reinforced, pre-cast concrete pipe.<sup>b</sup> The pipe was fabricated on site in accordance with the specifications shown in Table 2 using aggregate crushed from boulders found locally. Pipe walls were reinforced using “triangular wire mesh” in the weights shown in the table. An asphaltic coating was applied to the exterior of all pipes prior to installation (see Photograph 1). The Engineer’s report indicates that this was done as protection against “alkali which appeared at several points along the sewer.” The specifications indicate that the pipe was to be laid with the spigot end pointing toward the outfall (City Engineer’s Report, 1912).

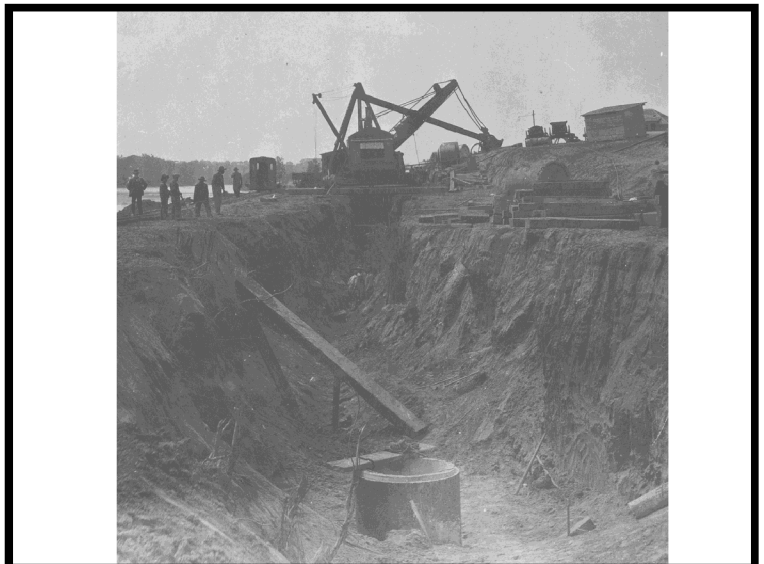
**Photograph 1-3**

Typical manhole installation with native  
bedding (on 1500 mm pipe)
